Coal Burner Condition and Estimated Remaining Life Evaluation of Intermountain Power Project Units 1 & 2

Final Report

Coal Burner Condition and Estimated Remaining Life Evaluation - Intermountain Generating Station

August 15, 1990

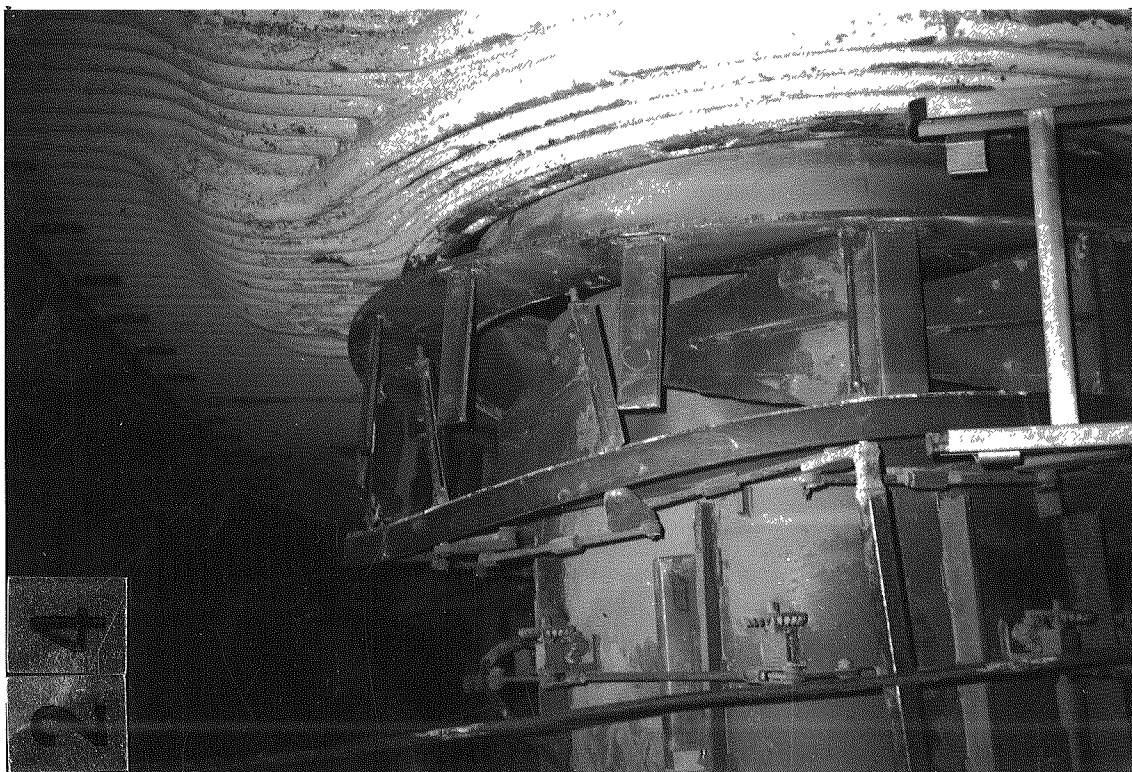
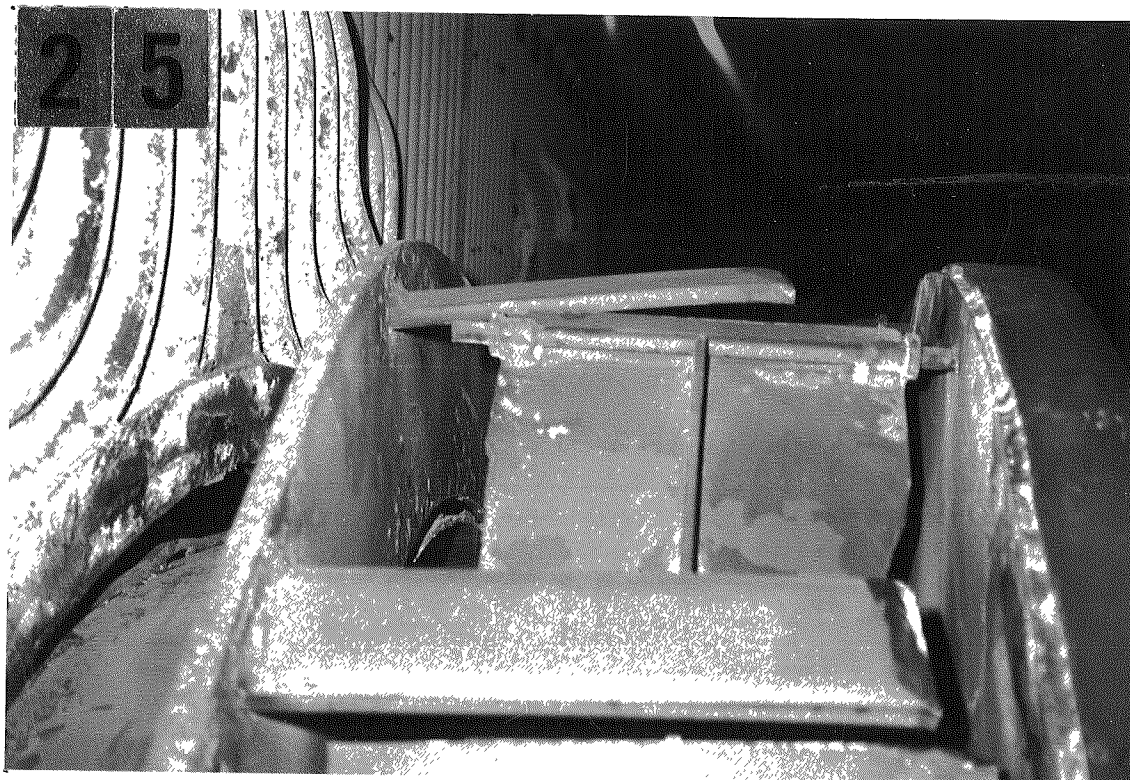
1. Welds were found broken on the support bar that connects the outer air register front and back plate together. This was found on four different burners. Burner C4 (Photos #24 & 25)¹ had six of these bars broken and the back plate had subsequently warped at least 6 inches.

Photo 24 - Major weld failure and severely warped register plates.

Photo 25 - Major weld failure and severely warped register plates.

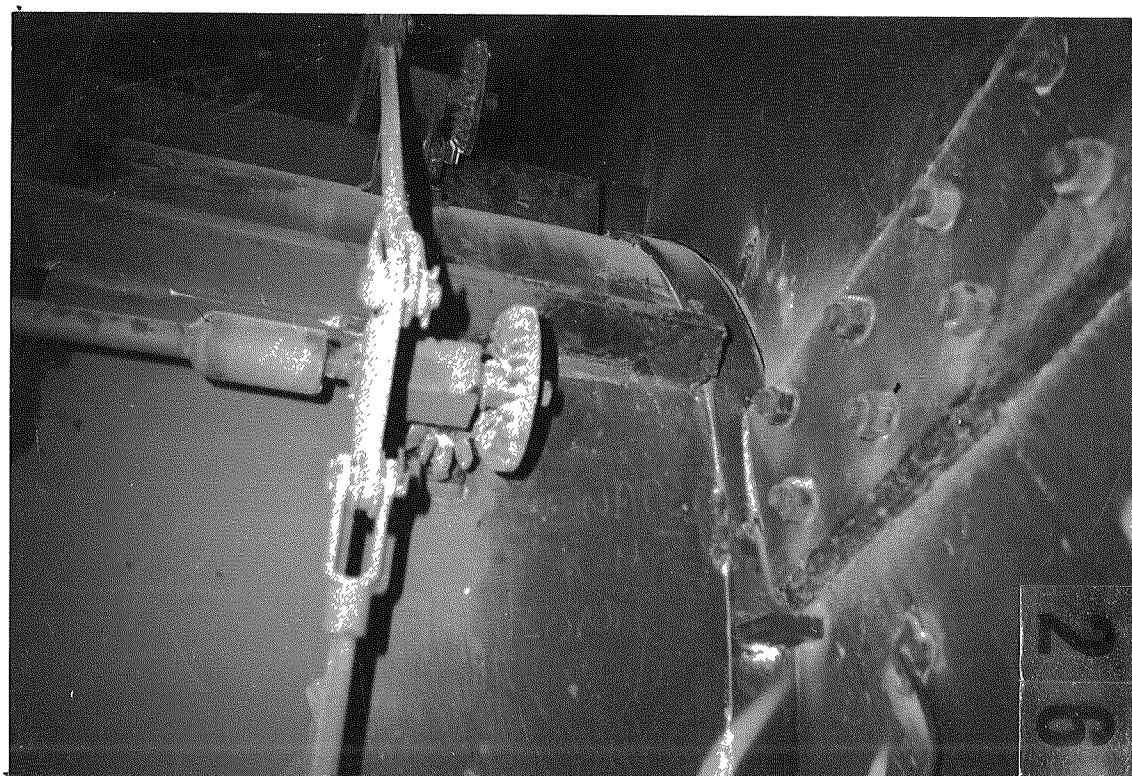
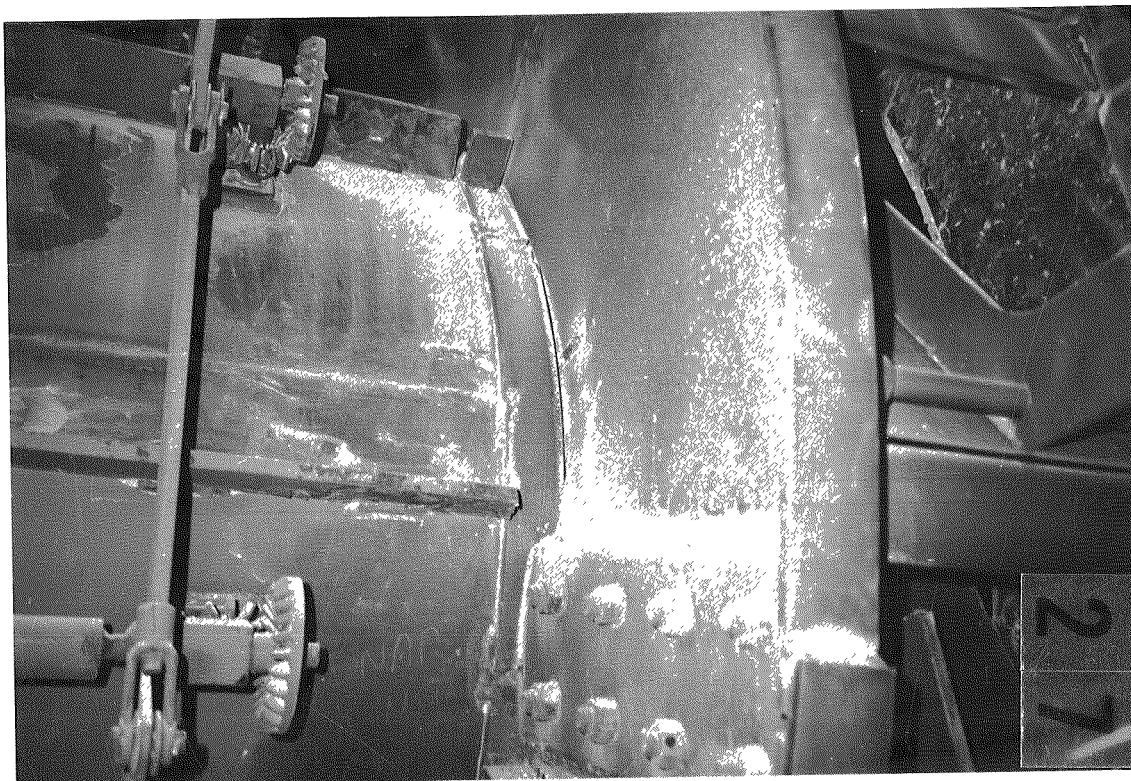
7. The reinforcing bars that are welded to the outside of the inner air sleeve (Photos #26 & 27) showed signs of overheating on twenty burners. Large flakes of metal broke away from the burner with only fingertip contact. This was not caused by cutting or field alterations since it was not found on all burners. The maximum recommended working temperature of this material had undoubtedly been exceeded. Also, one burner had broken welds where the reinforcing bar attached to the inner air sleeve.

The carbide phase of carbon steel may be converted to graphite when subjected to prolonged temperatures of above 800°F. For a wear part such as the coal nozzle and non-pressure parts, the maximum temperature for carbon steel should be limited to 850°F. The thermocouple on the coal nozzle is located at the junction of the stainless and carbon steels. This thermocouple should be set to alarm at 850°F. The reinforcing bars that are welded on the outside of the inner air sleeve have definitely exceeded their allowable temperature. Large flakes of material can be picked off of the bars and the material that remains is porous and brittle.

Photo 26 - Overheating of reinforcing bar on outside of inner air zone.

Photo 27 - Overheating of reinforcing bar on outside of inner air zone.

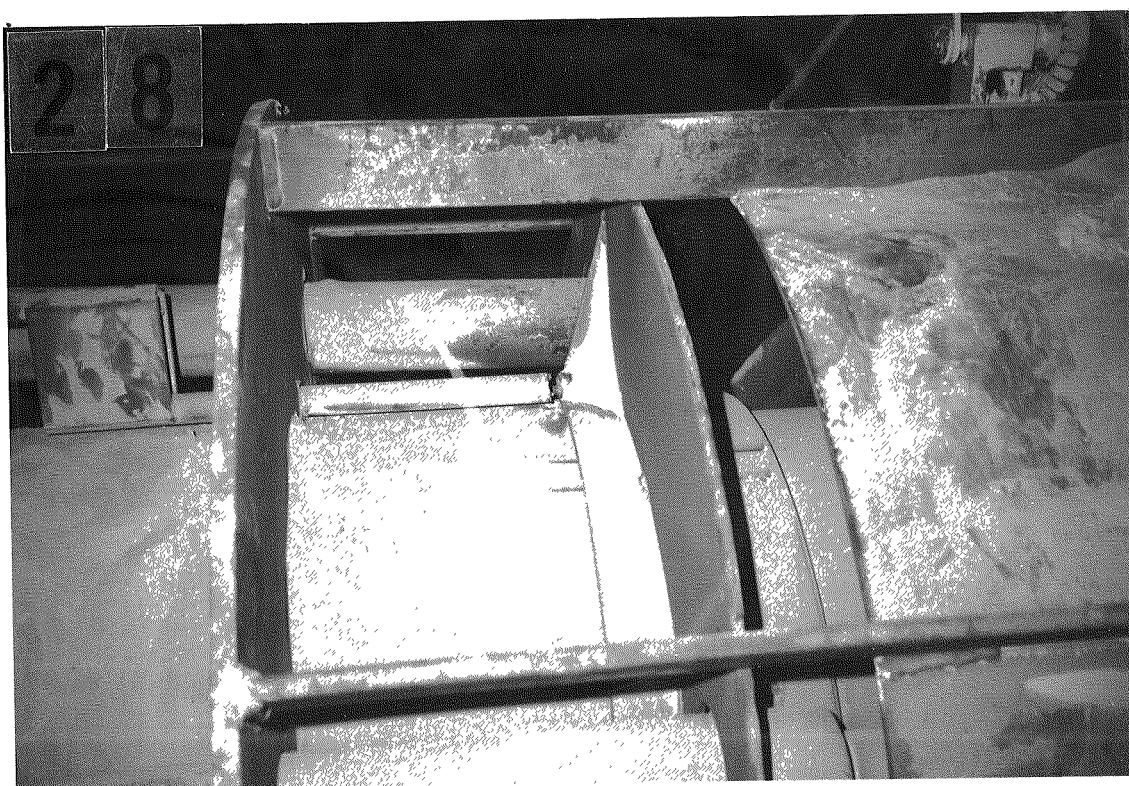
6. The weld that connects the pull handle to the inner air zone disk was completely broken on one burner (Photo #28). Another inner air zone disk was cocked at an angle from vertical and was being held there by the pull handle.

Photo 28 - Broken weld on inner air zone disk pull handle.
